Proceedings of the 1st International Conference on Structural Safety under Fire & Blast CONFAB 2015

‘IS UK BUILDING REGULATION GUIDANCE ON SERVICE PENETRATIONS ADEQUATE IN RELATION TO COMBUSTIBLE WALL OR FLOOR CONSTRUCTIONS?’

ABSTRACT

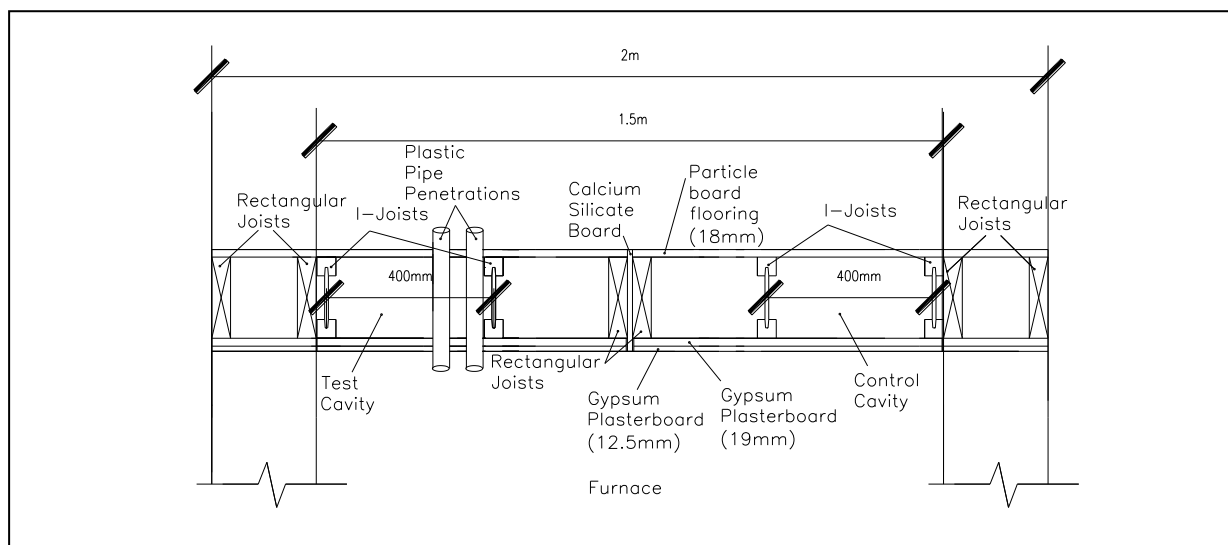
Figure 1: Section through Floor Sample

Three reduced scale fire resistance tests were conducted on 2 m x 2 m floor samples. The floor samples consisted of 18 mm flooring grade particle board on 195 x 45 mm timber I-joists at 400 mm centres. The I-joists comprised 45 mm x 47 mm softwood flanges at the top and bottom, connected to each other by a 9 mm thick OSB web. The underside of the I-joists was lined with a base layer of 19 mm gypsum wallboard and a further layer of 12.5 mm gypsum wallboard. This specification was identified within an I-joist manufacturers technical manual as one providing 60 minutes fire resistance [25]. In all cases the samples contained both a construction cavity

which was penetrated by plastic waste pipes and a control cavity with no penetrations. Figure 1 shows a section through the construction. The plastic pipes were positioned a nominal 2 mm away from the adjacent structural member. In all cases the plastic pipe material used was ABS. The pipe penetrations were tightly fitted within the apertures in the particle board flooring and gypsum plasterboard. The minimal annular space around the pipe penetrations remaining were then sealed with inert gypsum based plaster filler; this type of fire-stopping material being permissible in the guidance to the Building Regulations.

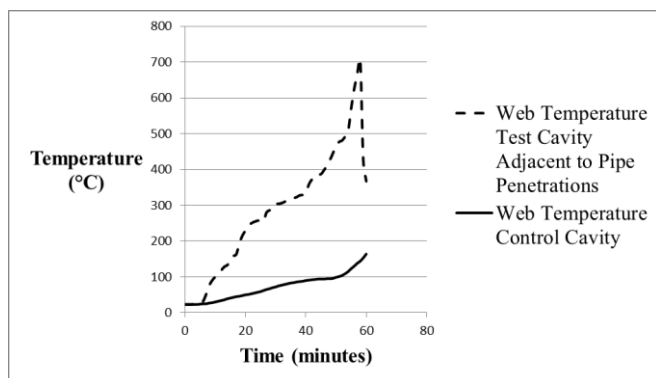
Figure 2: Web Temperatures Test 1

Figure 2 indicates the web temperatures to the I-joint adjacent to the pipe penetrations and the web temperature measured in the control cavity.

It may be seen from the graph that the web temperature in the cavity without service penetrations exceeds 100°C between 50-51 minutes and therefore would have been subject to some moisture migration. The maximum temperature of 164°C was reached by the end of the 60 minute test period. Therefore the temperatures associated with pyrolysis, ignition or charring was not reached.

By contrast, the thermocouple to the web immediately adjacent to the pipe penetrations in the test cavity exceeded 100°C after 10 minutes indicating the start of moisture migration. It subsequently reached 200 °C at 18-19 minutes; indicative of pyrolysis. 250°C was reached at 22 minutes, potentially conducive to ignition in a glowing mode. 300°C was reached at 29-30 minutes indicative of charring and at the bottom of the range identified for piloted direct flaming ignition. The top of this range for piloted flaming combustion ignition, 365°C, was reached at 41-42 minutes.

It is also worthy of note that the time/temperature history for the web temperatures in test 1 indicate better performance than those in tests 2 or 3, suggesting that the limitation on spacing or number of pipe penetrations unique to Scottish Building Regulation guidance is material.

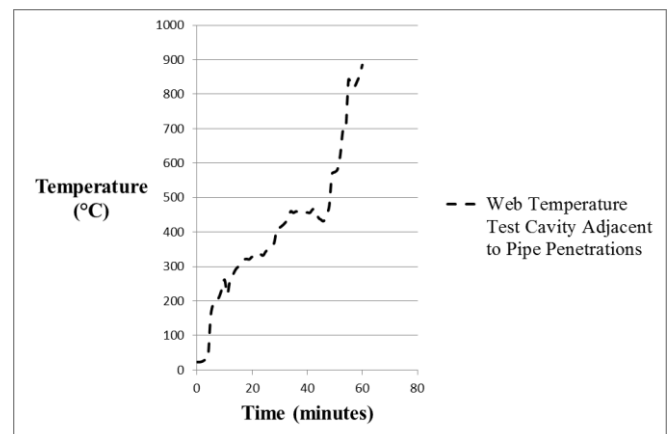
Figure 3: Web Temperature Test 2

Unfortunately the thermocouple to the control cavity I-joint web malfunctioned during this test and therefore a direct comparison between the control and test cavities was not possible. However a post-test examination of the I-joists from the control cavity confirmed that the web, although discoloured, was not charred.

With reference to Figure 3 it may be seen that the web to the I-joint in the test cavity reached 100°C between 4-5 minutes indicating the start of moisture migration; 200°C between 7-8 minutes, indicative of pyrolysis; 250°C between 9-10 minutes, potentially conducive to ignition in a glowing mode; 300°C between 14-15 minutes indicative of charring; and 365°C between 27-28 minutes, the top of the range for piloted flaming combustion ignition.

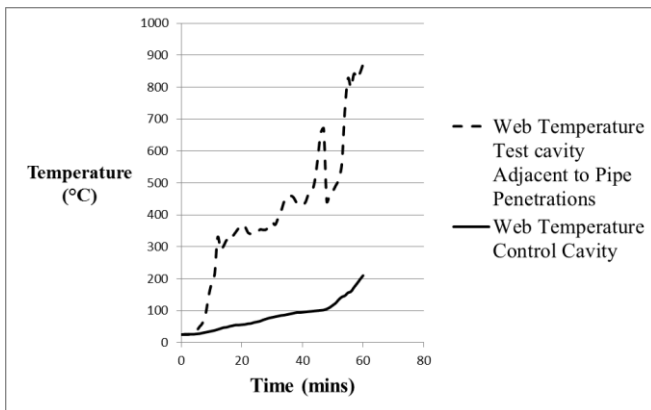
Figure 4: Web Temperatures Test 3

The web temperature in the control cavity exceeded 100°C at 45 minutes, indicating the start of moisture movement in the OSB board and exceeded 200°C at 59-60 minutes indicating potentially the start of pyrolysis.

The I-joist web in the test cavity reached 100°C between 8-9 minutes indicating the start of moisture migration; 200°C between 10-11 minutes, indicative of pyrolysis; 250°C between 11-12 minutes, potentially conducive to ignition in a glowing mode; 300°C also between 11-12 minutes indicative of charring and 365°C between 19-20 minutes, the top of the range for piloted flaming combustion ignition.

The experiments indicate that in each case web charring and ignition of the timber I-joist in the test cavity took place, whereas no charring or ignition of the web occurred in the control cavities. In all three experiments post-test examination showed that the test cavity web had charred through its entire thickness. It should be pointed out however, that due to the nature of the test furnace arrangement, extinguishment of the floor samples did not take place until approximately four minutes after the furnace was turned off.
